Byrd Park Main Pumping Station Upgrade

Project Narrative

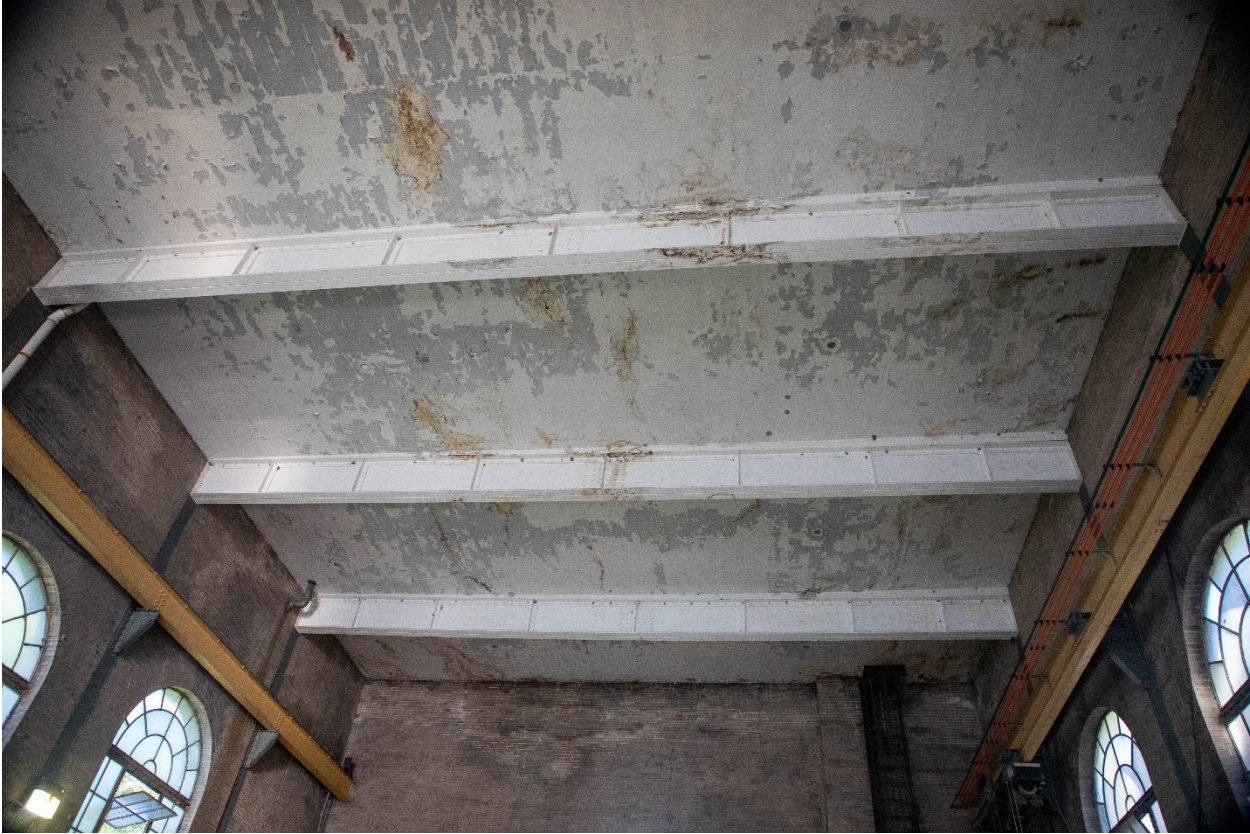
Water leaks through the roof structure.

The station roof is a low slope roof that is overdue for replacement. The roofing membrane is completely loose, and portions of the insulation underneath are exposed to the elements. Rainwater accumulation and vegetation are accumulating and growing on the roof compromising the integrity of the structure. Water leaks are present in the interior compromising the electrical equipment inside and posing a fire risk that can take the pump station out of service. The scope of work includes the immediate replacement of the roof.

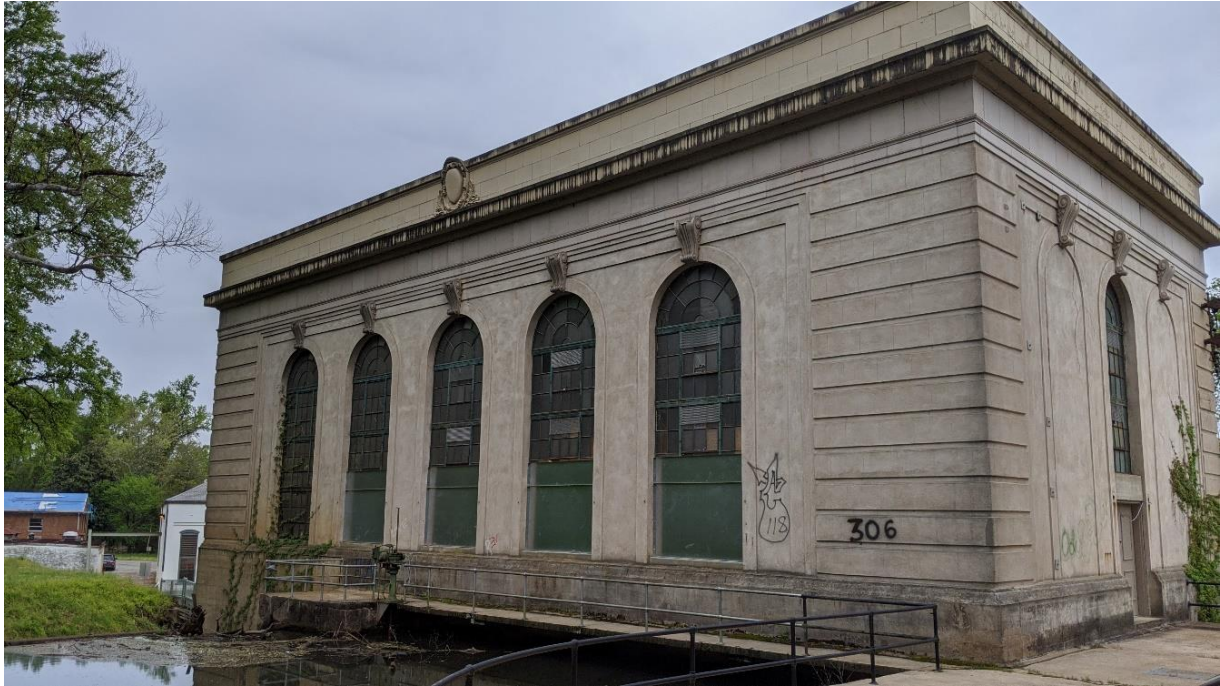
The North façade showing current blank off panels.

The bottom portion third module of the windows on the north façade has been covered with a metal panel to prevent extended vandalism damage.

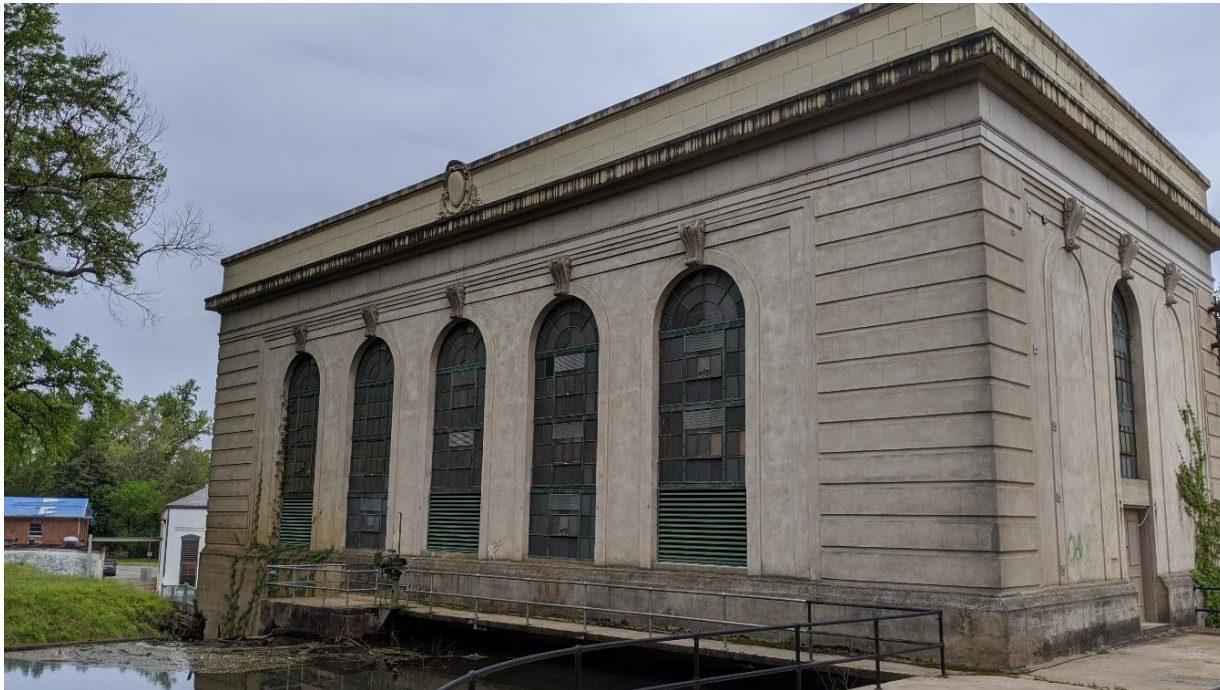
The North façade as it could look with the new louvers installed.

For functional purposes the proposed louvers have to be located on the lower portion of the building to allow air to be captured low and exhausted high up on the roof. To maintain the aesthetics of the station and the integrity of the façade, as well as the ventilation functional needs, the louvers need to be located at the bottom of the windows. The louvers will be made of anodized aluminum painted in a dark color to match the main sight lines and the green color of the existing window frames.

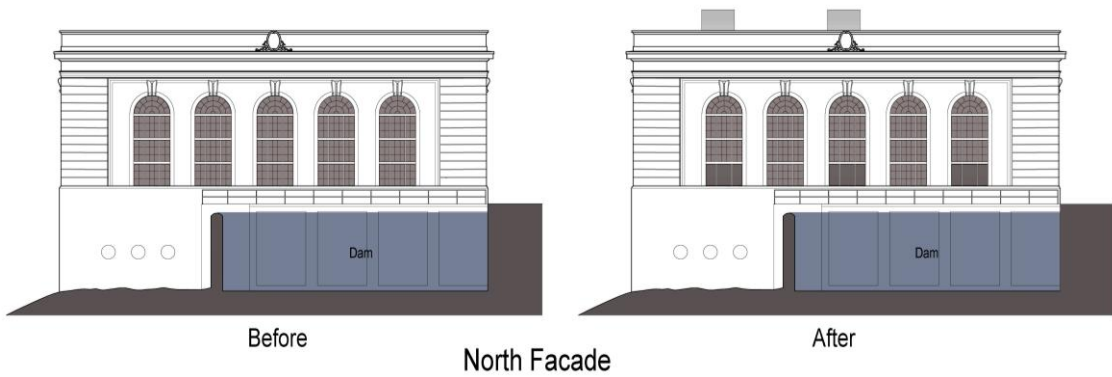
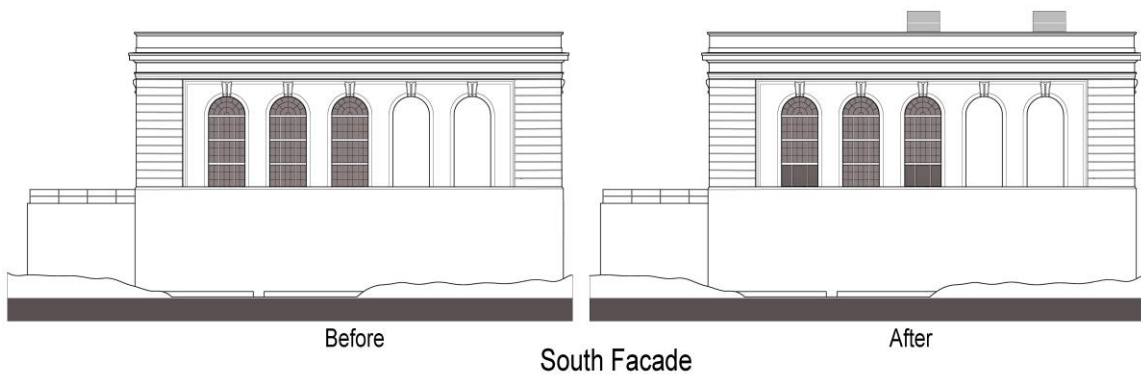
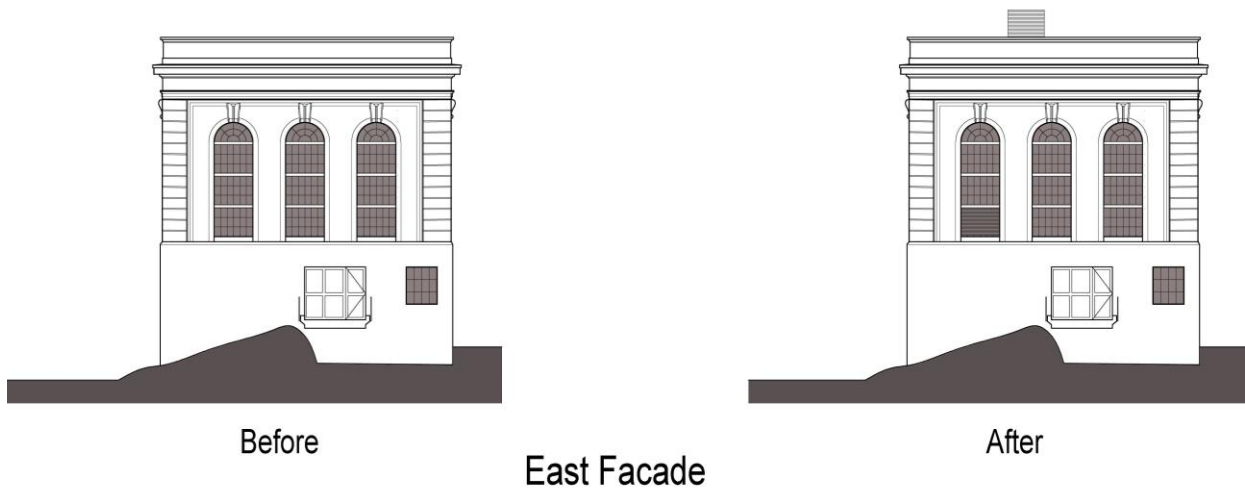
The drawings below show the original look of the facades and the proposed look after the new louvers are installed at the bottom window panel.

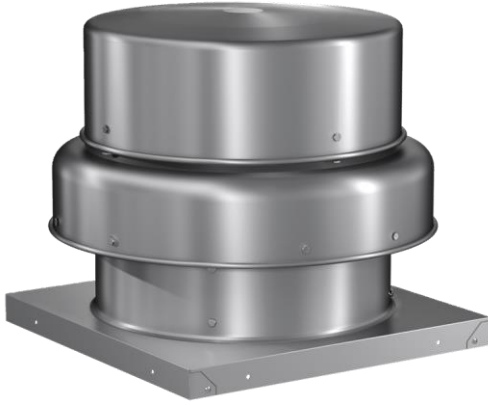
Conventional mushroom type fan

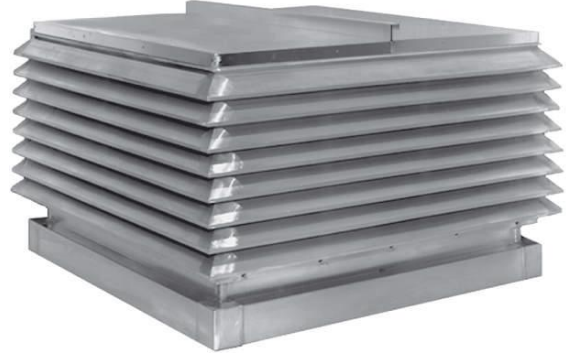
Proposed louvered type exhaust fan

The louvered enclosure will be aluminum made and painted in a color to match the exterior stucco tone of the building's façade.

To provide the required building ventilation, exhaust fans are required to be installed on the roof. This way fresh air will be drawn into the building through the louvers at the bottom of the windows and pulled up to the roof and out to the exterior by the exhaust fans located on the roof. Instead of installing conventional industrial type mushroom shaped exhaust fans, two new

louvered centrifugal fans will be located on roof to mitigate the visual impact they may have when seen from far away on the building façade.

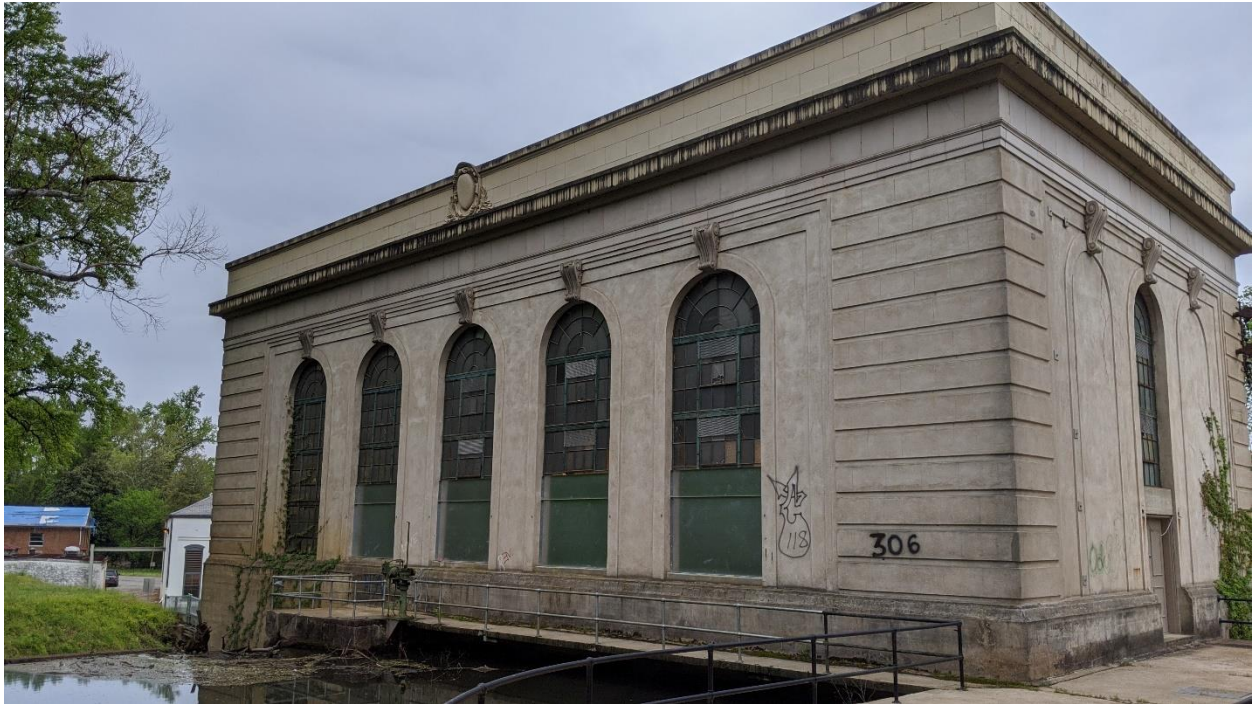
North façade showing the existing blank off panels at the bottom of the windows.
